Manhole Inspection Summary

Manhole # S4100_014MH

Insp Date: **2/21/07 10:09 AM**

Location Address: **2208 AISQUITH ST**

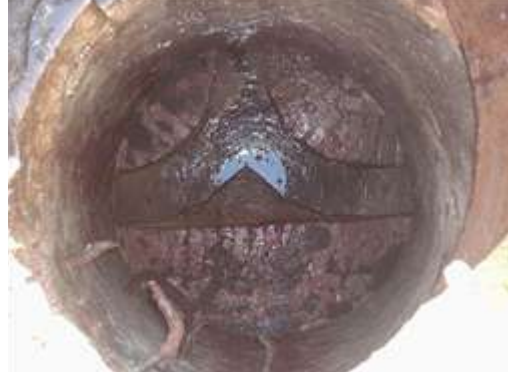
Top View

Corroded and missing steps. Evidence of surcharge - Bench debris. Channel debris.

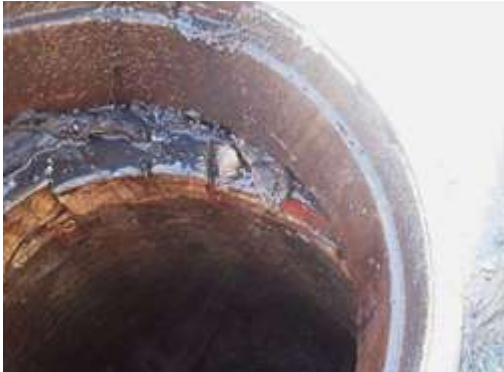
Defect

Frame leaks. Frame offset. Adjustment deterioration, loose brick and infiltration.

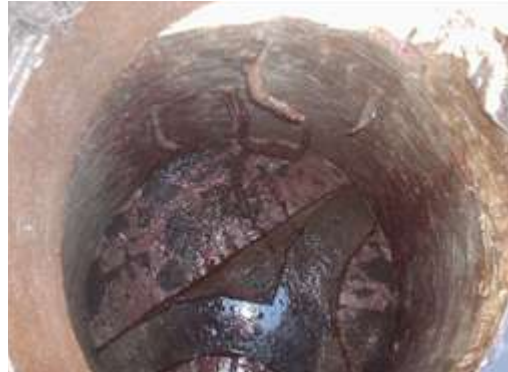
Defect

Frame leaks. Frame offset. Adjustment deterioration, loose brick and infiltration - other side.

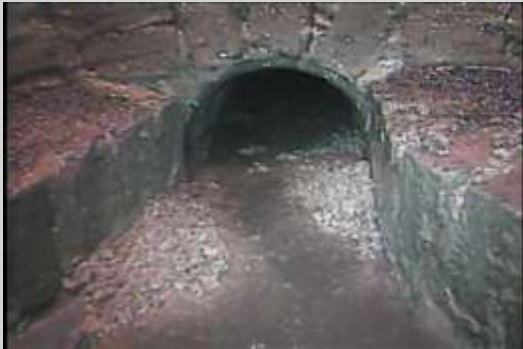
8 in. Circular Gravity Sewer Pipe Out @ 12 O'Clock

Deposits: ☐ None ☒ **Mud** ☐ Sludge ☐ Debris ☒ **Grease**

Silt Depth: **3** (in.) Deposits Extent: **Medium**

Infiltration: **Evidence** Pipe Seal Cond: **Unknown**

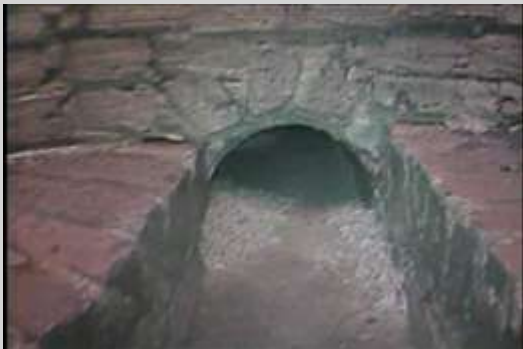
8 in. Circular Gravity Sewer Pipe In @ 3 O'Clock

Deposits: ☐ None ☒ **Mud** ☐ Sludge ☒ **Debris** ☐ Grease

Silt Depth: **3** (in.) Deposits Extent: **Medium**

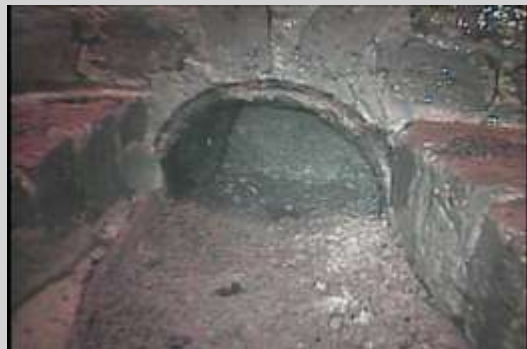
Pipe In @ 9 O'Clock

Connects To: **Stub connection / abandoned**
☐ Possible Illicit Connection
